Project Overview

During inspections of their road culverts, the City of Rock Springs discovered a corrugated metal culvert that was considered in danger of imminent failure. The 700 foot long culvert in question was arched with a maximum height of 48 inches and a maximum width of 72 inches.

Application: Arched storm culvert

Location: Rock Springs, WY

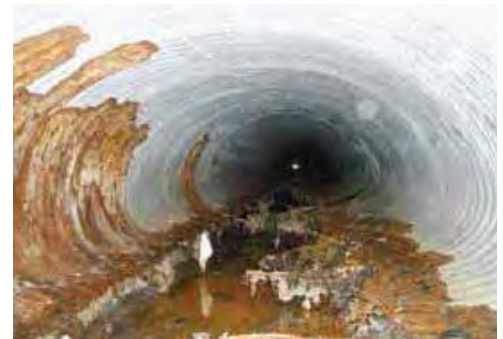
The invert of the pipe, which was covered with dirt and trash, was mostly corroded away. In fact, approximately 18 inches of the underlying soil had been eroded along the full length of the culvert. In addition to the invert, there were joint separations of more than six inches in many of the joints. The crown had also caved in over a 10-foot section of the structure running directly under the road. The situation was clearly dire.

Severely corroded CMP invert

The major flaws in the pipe were then addressed. The timber bracing was used to return the crown to its original shape. Standard Portland cement fill was laid in the invert of the culvert to replace the missing soil and the joints were repaired.

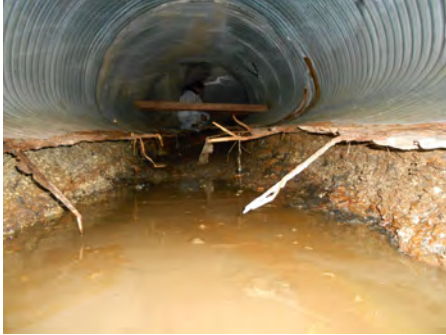
Invert needed to be repaired prior to application of geopolymer

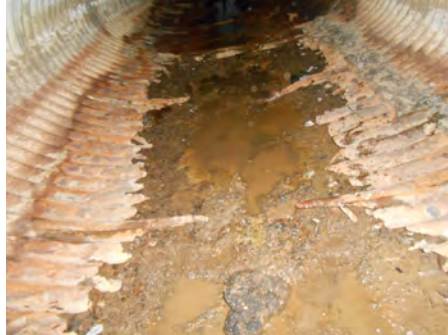
Severe invert corrosion

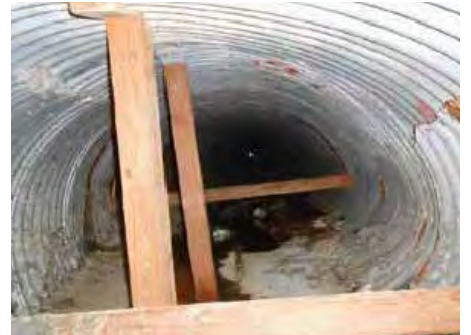
Asset owners had used timber as a temporary structural support

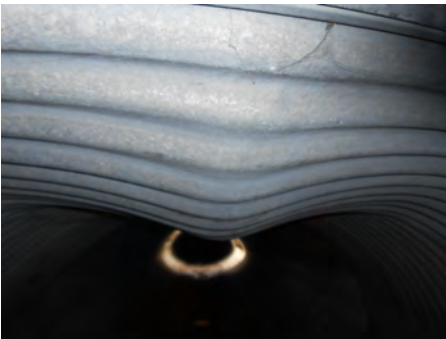
Crown damage likely from time of install

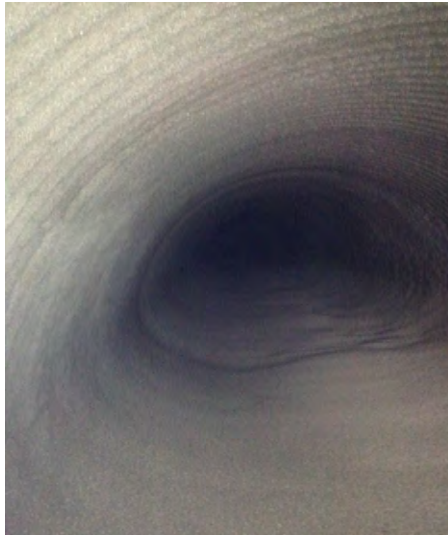
Completed arched pipelining

Once the basic shape of the pipe was returned to normal, the GeoSpray liner was applied to return the structural integrity of the system and create a like-new condition. The liner was applied using standard spray nozzle techniques to a final thickness of 1.5 inches. The inlet and outlet of the culvert were also treated with GeoSpray liner to create a monolithic structure.

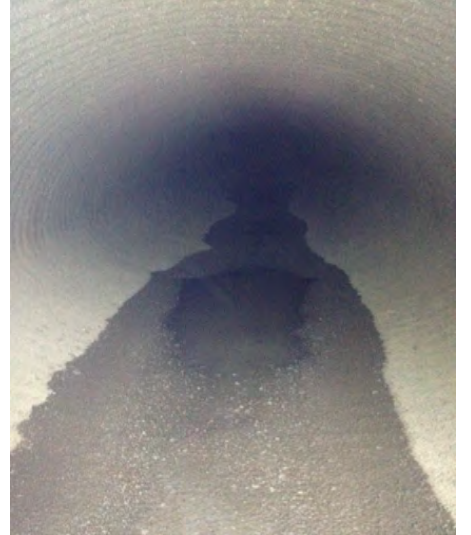
Final geopolymer pipe
